DARRIN
Fresh Water Institute

Saratoga Lake Aquatic Plant Survey – 2019

December 3, 2019

DFWI Technical Report 2019-9

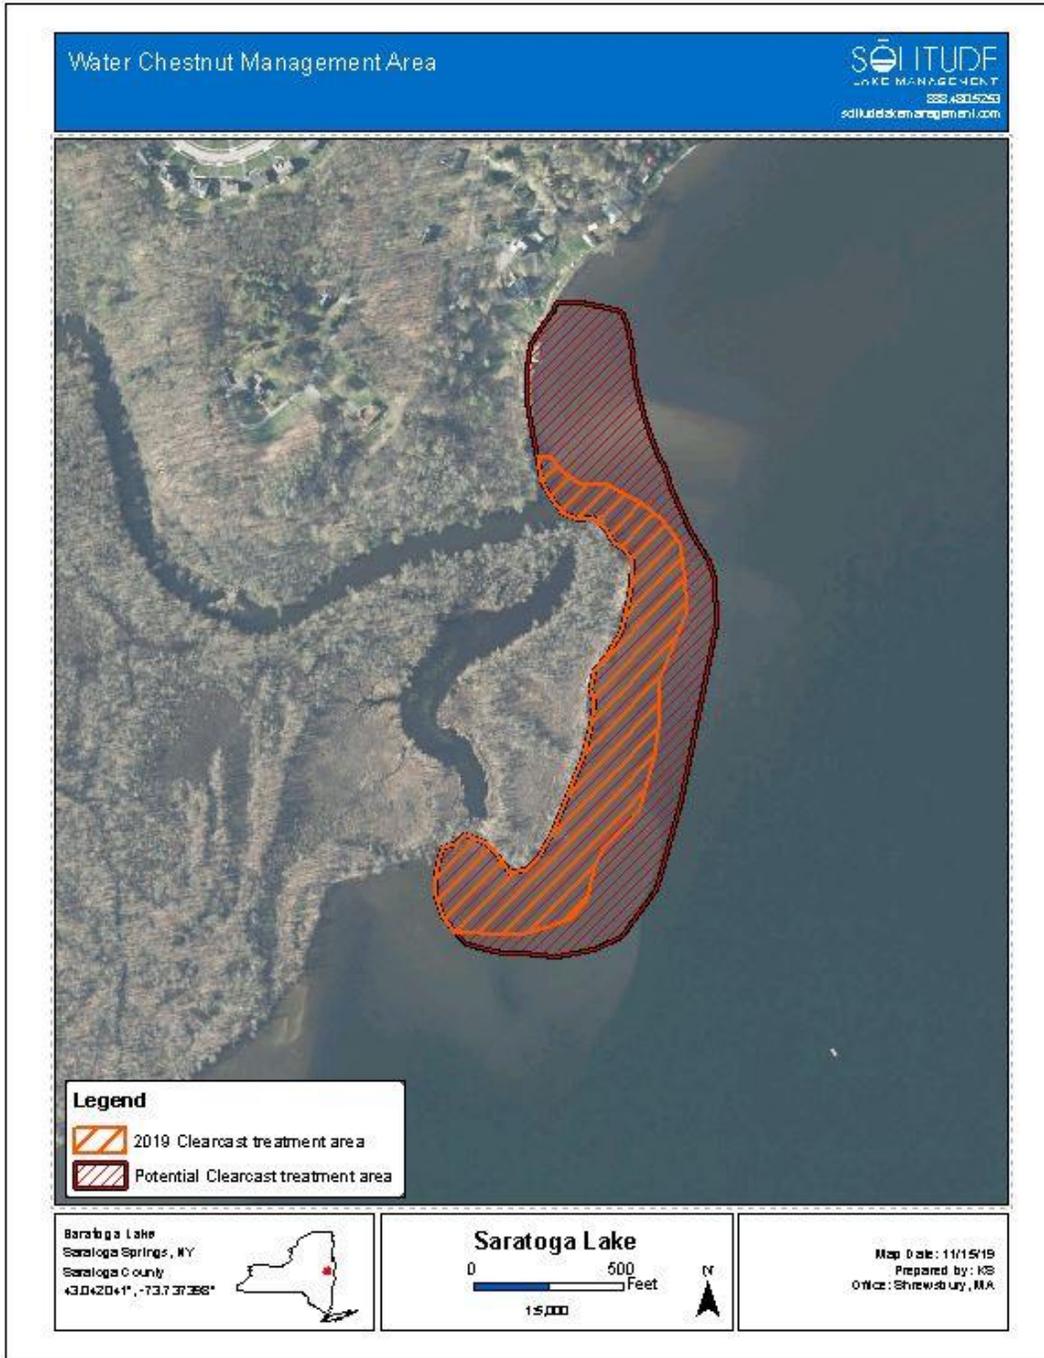
Treatment area maps courtesy of Solitude, Sutton, MA.

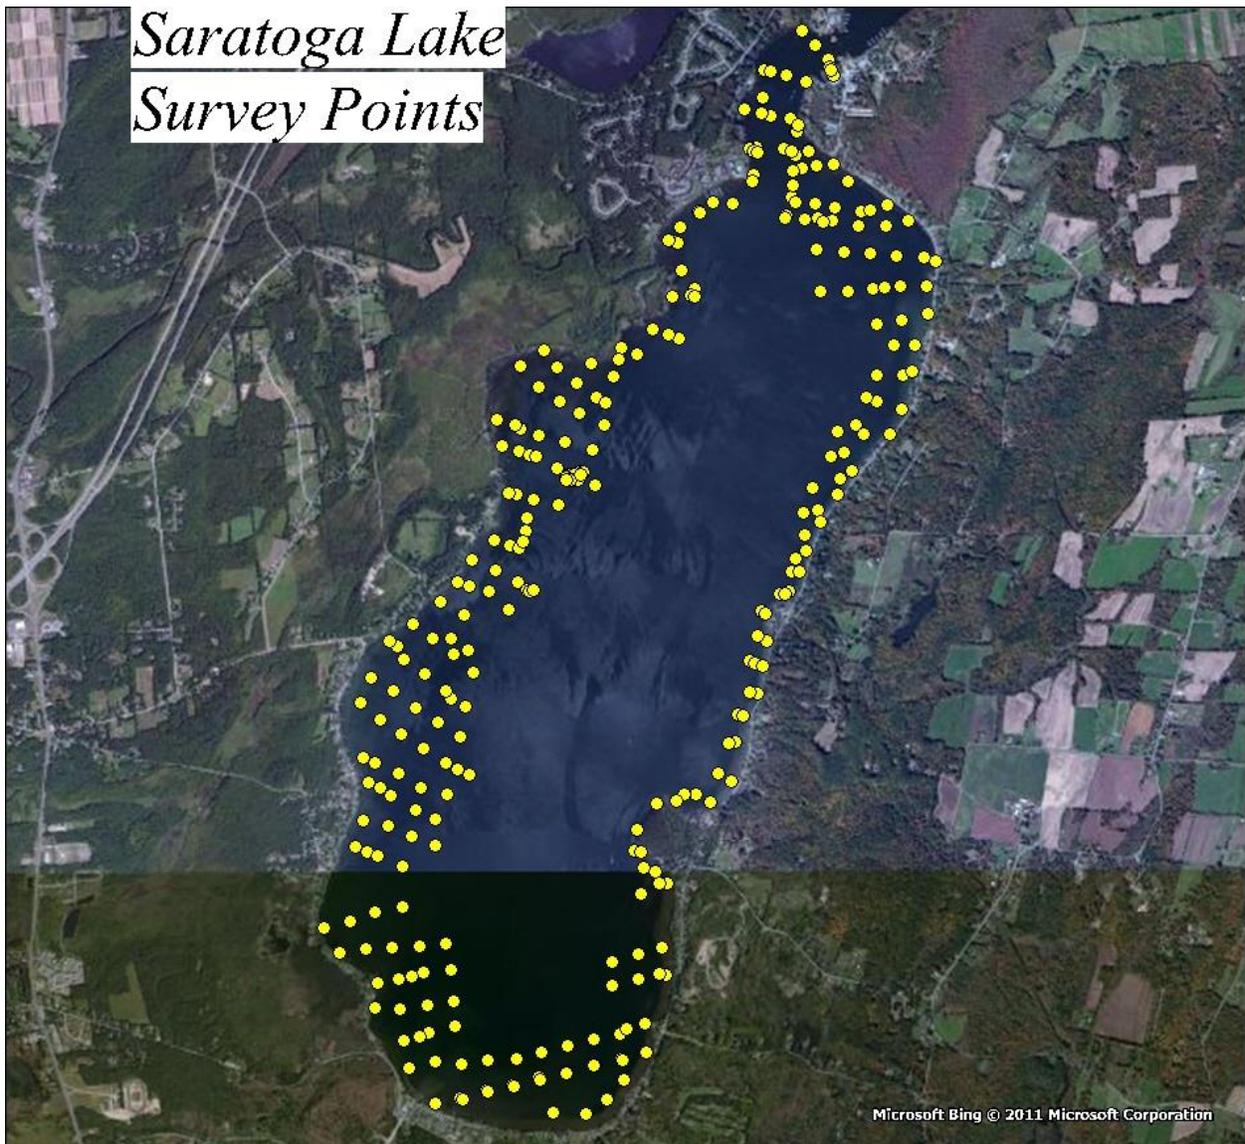
Figure 1. Distribution of point intercept survey points for Saratoga Lake aquatic plant survey.

located at that point were recorded, as well as water depth. Species were located by a visual inspection of the point and by deploying a rake to the bottom, and examining the plants retrieved. A differential global positioning system (Garmin GPSmap 168) was used to navigate to each point for the survey observation. Point intercept plant frequencies were surveyed on August 22 and 23 of 2019, at the time of maximum aquatic plant abundance. Based on an 80 m grid and excluding nearly all points outside the littoral zone, a total of 310 points were surveyed. The point intercept method allows a large number of discrete observations in a short period of time facilitating statistical analysis and comparisons. Point intercept methods also allow for production of distribution maps for all species listed (Figure 1).

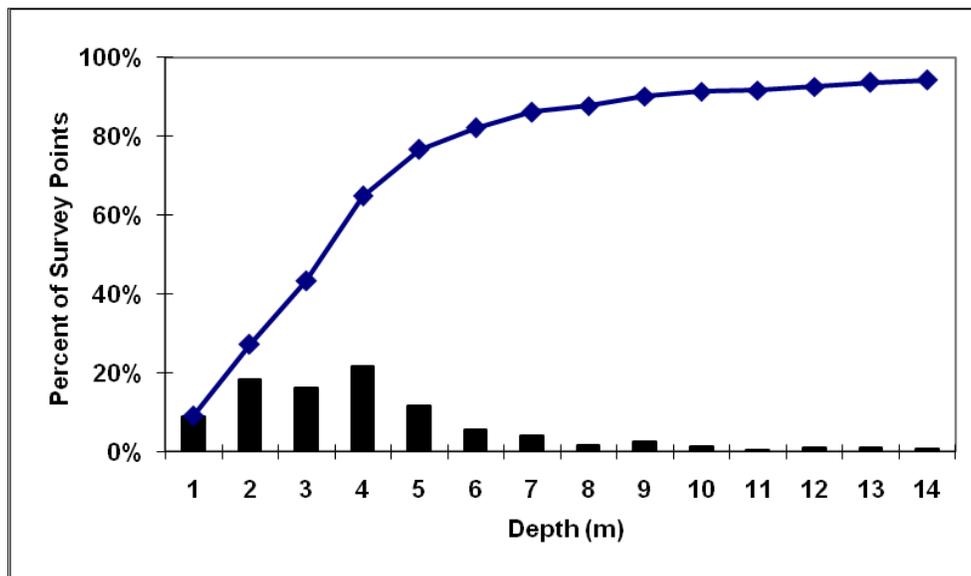
Figure 2. Depth Distribution of Saratoga Lake sampling points in 1 meter depth classes.

Maximum depth of colonization by rooted aquatic plant growth extended to a depth of 6 meters. Calculated maximum depth of colonization (MDOC) by macrophytes ranged from 4.3 to 4.9 meters in 2004 (Eichler and Boylen 2004), and was comparable to 1994 records (Eichler and Boylen 1995). Specimens of *Ceratophyllum demersum*, *Najas guadalupensis* and *Myriophyllum spicatum* were found between 5 and 6 meters depth in most years. Thus, 6 meters is the maximum extent of the littoral zone, representing an increase of approximately 1 meter in depth from 1994 estimates (Eichler and Boylen 1995) and comparable to depth records for 2004 (Eichler and Boylen 2004) and 2007 (Eichler and Boylen 2008). Depth distribution of sampling points (Figure 2) was equitable throughout the littoral zone in 2007 thru 2019.

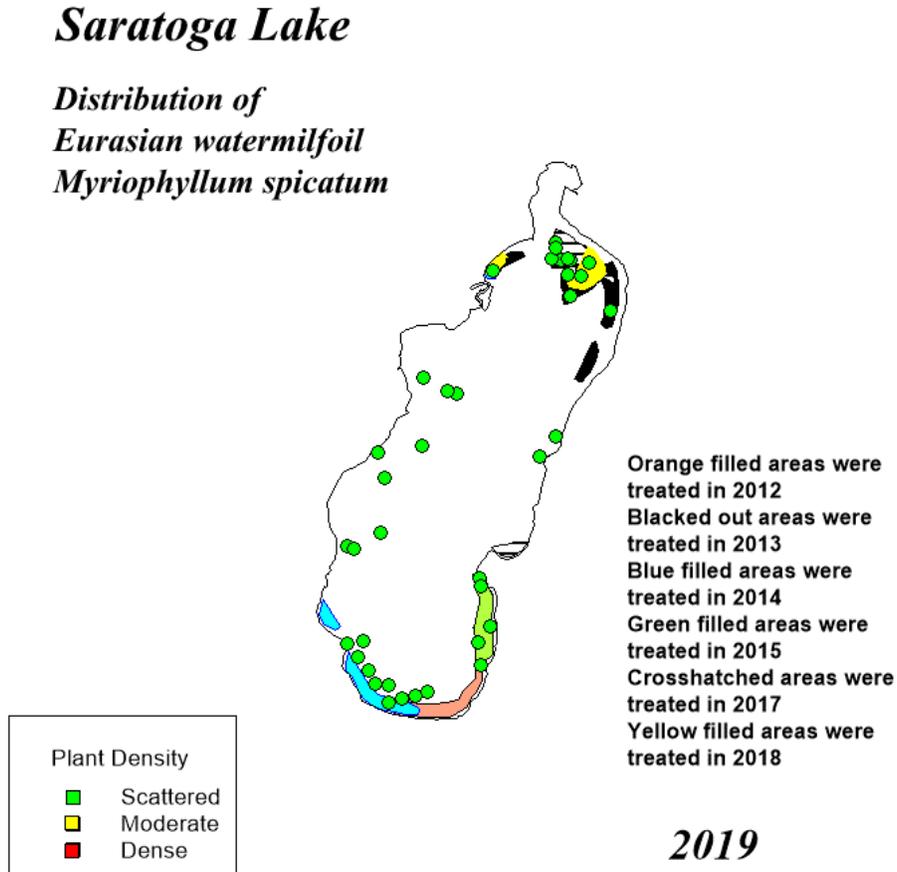
Figure 3. Distribution of Eurasian watermilfoil (*Myriophyllum spicatum*) in surveyed areas of Saratoga Lake in 2019.

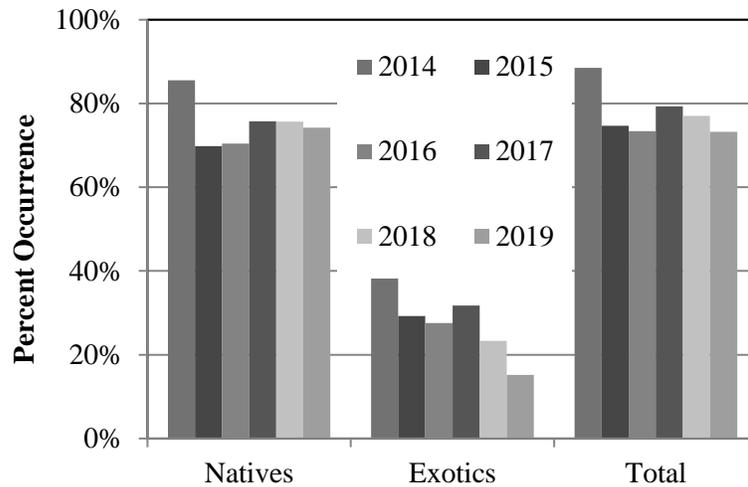
Figure 4. Saratoga Lake frequency of occurrence summaries for all sampling points.

Eighty-nine percent of whole lake points were vegetated by native plant species in 2010, 80% in 2011, 79% in 2012, 72% in 2013, 79% in 2014, 70% in 2015, 71% in 2016 and 76% in both 2017 and 2018 and 73% in 2019 (Figure 4). In depths less than 6 m, representing the littoral zone, 81% of survey points contained native species and 89% of survey points less than 2 meters depth yielded native aquatic plants in 2019. Eurasian watermilfoil was present in 13% of whole lake survey points, and 14% of survey points within the littoral zone or zone of aquatic plant growth. Exotic species, dominated by Eurasian watermilfoil, were more abundant lake-wide in 2004, 2007 & 2008 (56%, 53% and 18% of survey points, respectively) than in 2009 (10% of survey points). With only ‘spot’ treatments conducted in 2010 and 2011, Eurasian watermilfoil recovery to 29% and 33% of survey points was reported. With a larger treatment area in 2012 and 2013, Eurasian watermilfoil declined to 26% and 23% of survey points, respectively. In 2014, Eurasian watermilfoil increased to 37% of survey points, declined to 27% of survey points in 2015 and remained at that level in 2016 thru 2018 at 26%, 29% and 20% of survey points, respectively.

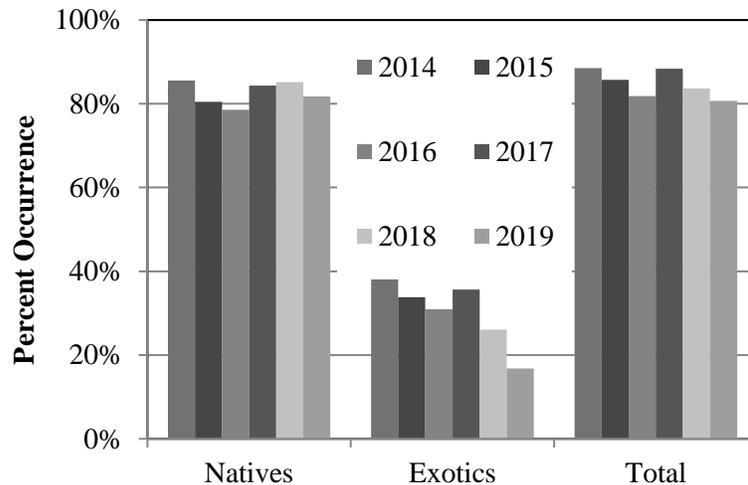
Figure 5. Saratoga Lake frequency of occurrence summaries for sampling points less than 6 meters water depth.

For survey points within the littoral zone, water depth less than 6 m (Figure 5), results are similar to whole lake surveys. The impact of the herbicide treatment for 2009 was less apparent on the relative abundance of exotic species when comparing treated (11% of survey points) and control sites (12%), most likely due to the fact 2009 is the final year of a 3 year program to treat the whole lake. Eurasian watermilfoil declined from 31% of littoral zone survey points within the treatment area in 2008 to 11% of comparable survey points post-treatment in 2009. In 2010, an increase in the frequency of occurrence of Eurasian watermilfoil, to levels comparable to 2008, was observed. Eurasian watermilfoil declined from 40% of survey points in 2010 to 33% of

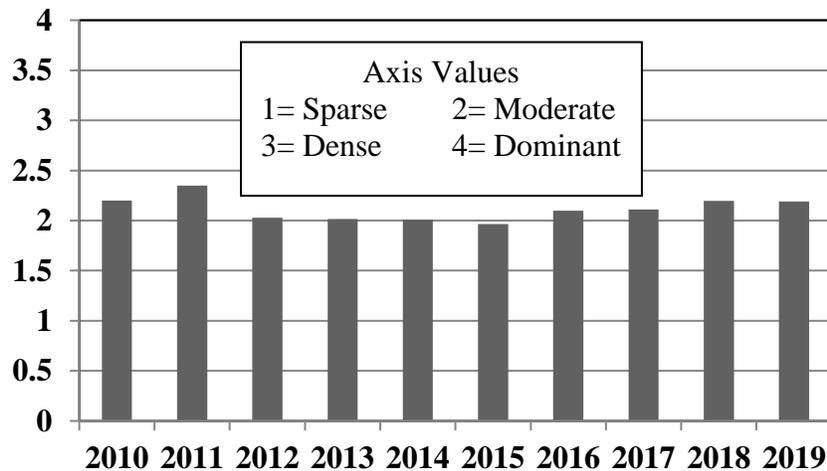
Relative Abundance of Eurasian watermilfoil

Figure 6. Lake-wide relative abundance of Eurasian watermilfoil in Saratoga Lake.

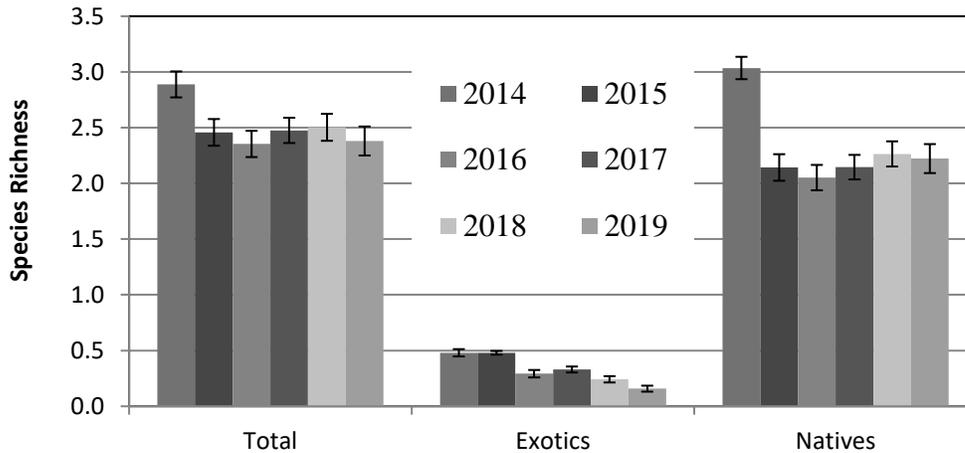
Figure 7. Saratoga Lake species richness. Error bars are standard error of the mean.

Species richness results for the point intercept survey are presented in Table 3 and Figure 7. In 2004 whole lake species richness was 2.00 ± 0.10 species per survey point. Whole lake species richness increased steadily from 2.31 ± 0.17 in 2007 to 3.47 ± 0.12 in 2010. In 2011, species richness lake-wide was comparable to 2009 at 2.81 ± 0.11 species per sample and slightly greater than the 2.65 ± 0.12 and 2.61 ± 0.13 reported in 2013. Species richness in 2014 once again

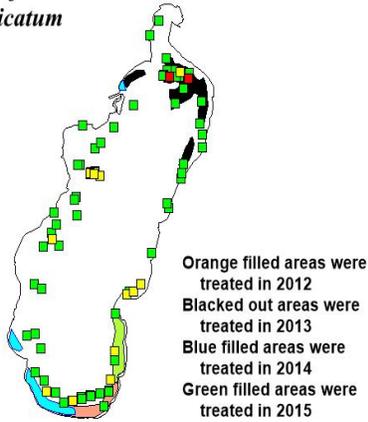
2016

Distribution of
Eurasian watermilfoil
Myriophyllum spicatum

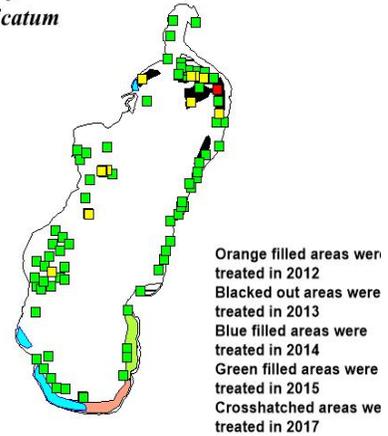
2017

Distribution of
Eurasian watermilfoil
Myriophyllum spicatum

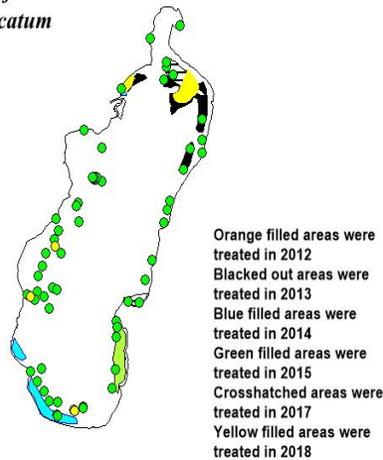
2018

Distribution of
Eurasian watermilfoil
Myriophyllum spicatum

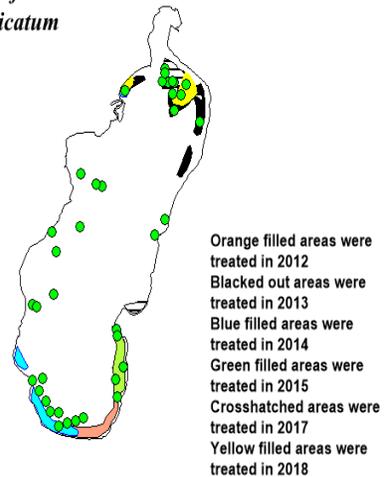
2019

Distribution of
Eurasian watermilfoil
Myriophyllum spicatum
