SLPID

2022 WINTER NEWSLETTER

2022 Saratoga Lake TEMPERATURE STUDIES

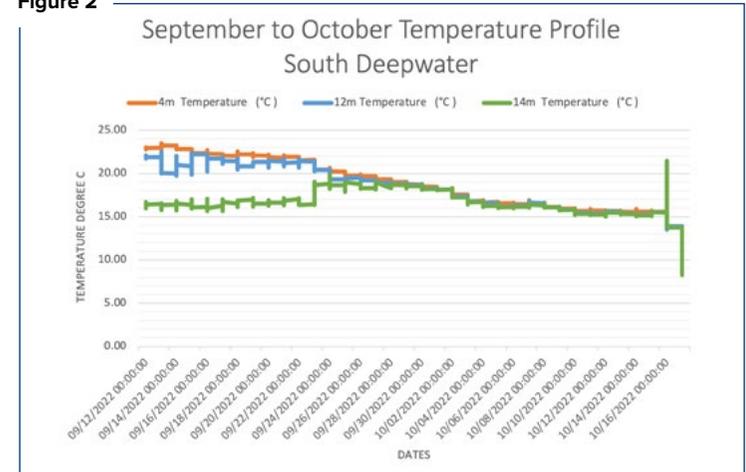
Figure 2 shows temperature change during that time period for three depths in the water column as horizontal lines. When all horizontal line meets the lake has become isothermal (nearly equal temperatures at all depths) and mixing will occur.

The first set of temperature profiles were collected between August to the middle of October and demonstrated that the lake mixing occurred at the end of September and the first days of October in the South deepwater area at Snake Hill.

The lake mixing occurred following the HABs event in September, this indicates that nutrient regeneration from full mixing did not contribute to the HABs event. With more temperature data collection, it may reveal if metalimnion mixing is contributing to HABs events.

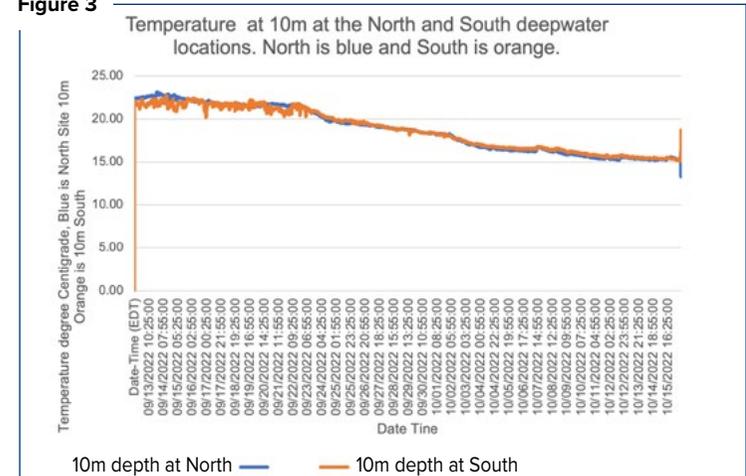
Figure 3

The continuous collection of water temperature does show that the profile is not static, and that in the South deepwater area near Snake Hill there is greater temperature variation at the same depth. **Figure 3** the orange line shows that temperatures at a depth of 10m varied 0.2-9 °C on given days between September 13, to September 24,2022 at the south deepwater zone while at the North site there was slight variation in temperature.

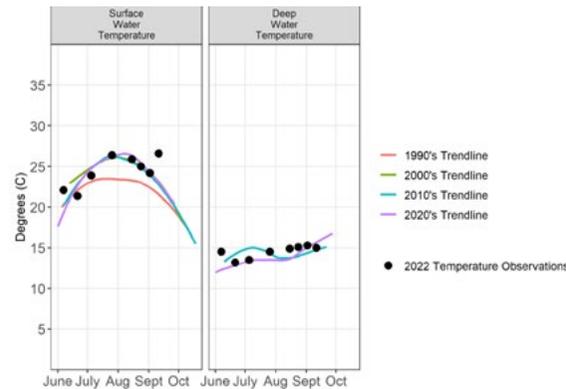
Water Temperature

Previous decadal trends are shown compared to 2022 field data. Trend lines are created by averaging previous years together, if applicable. Compared to previous years, aquatic plant coverage was less favorable in 2022. Surface water temperature, deep water temperature, water quality evaluation and recreational evaluation in 2022 were similar to previous years. There is insufficient data to identify trends in the other field data parameters. Further analysis will be available in the annual report available next spring.
